# Israel Beetison House

Conditions and Structural Assessment

Prepared by Melissa Gengler  
and Mike Eisenbarth

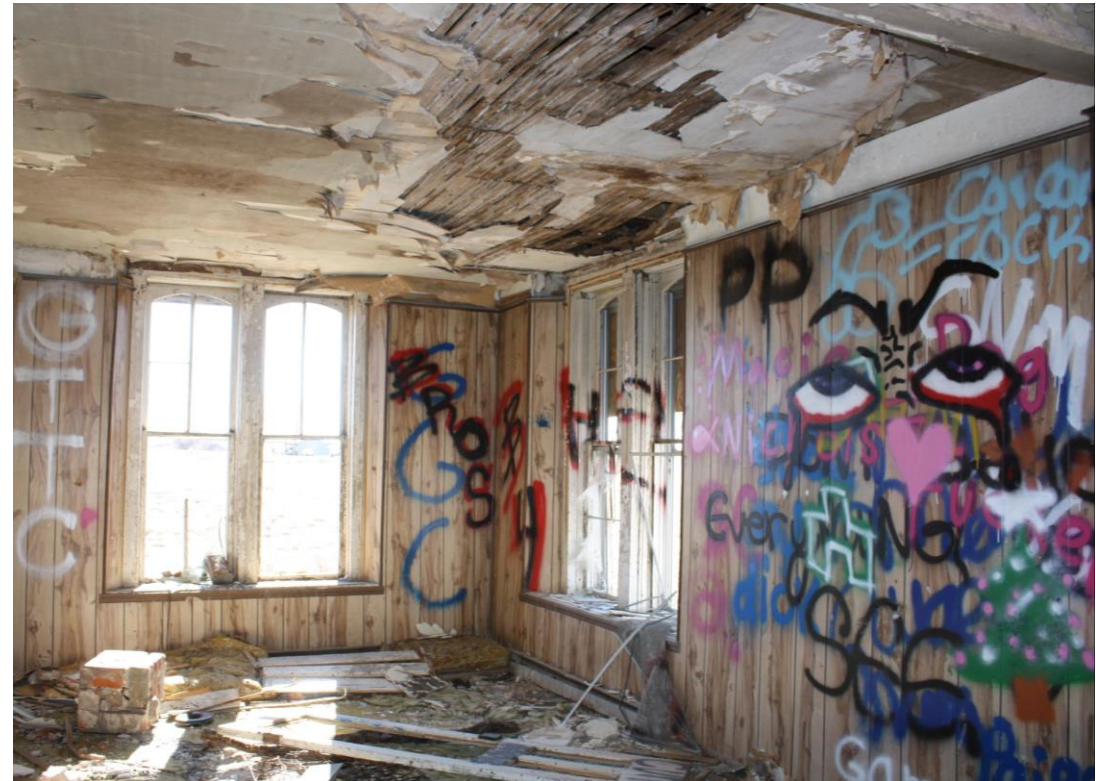
- Framed with full 2x8s spaced 12 inches on center.
- Joist bearing along the east basement wall has shifted and the wood sill plate is separating from the wall
- Ceiling originally plaster with wood lathe fastened directly to bottom of second floor framing

- No historic character defining features remain within building.
  - Structural stabilization and total renovation required.
- Replace roofing and deteriorated skip sheathing
  - Strengthen/replace damaged wood framing
  - Rebuild masonry arches and repair or replace stone lintel over basement stair
  - Repoint
  - Shore and rebuild joist bearing
  - Enclose building envelope
  - Install steel caps over chimneys

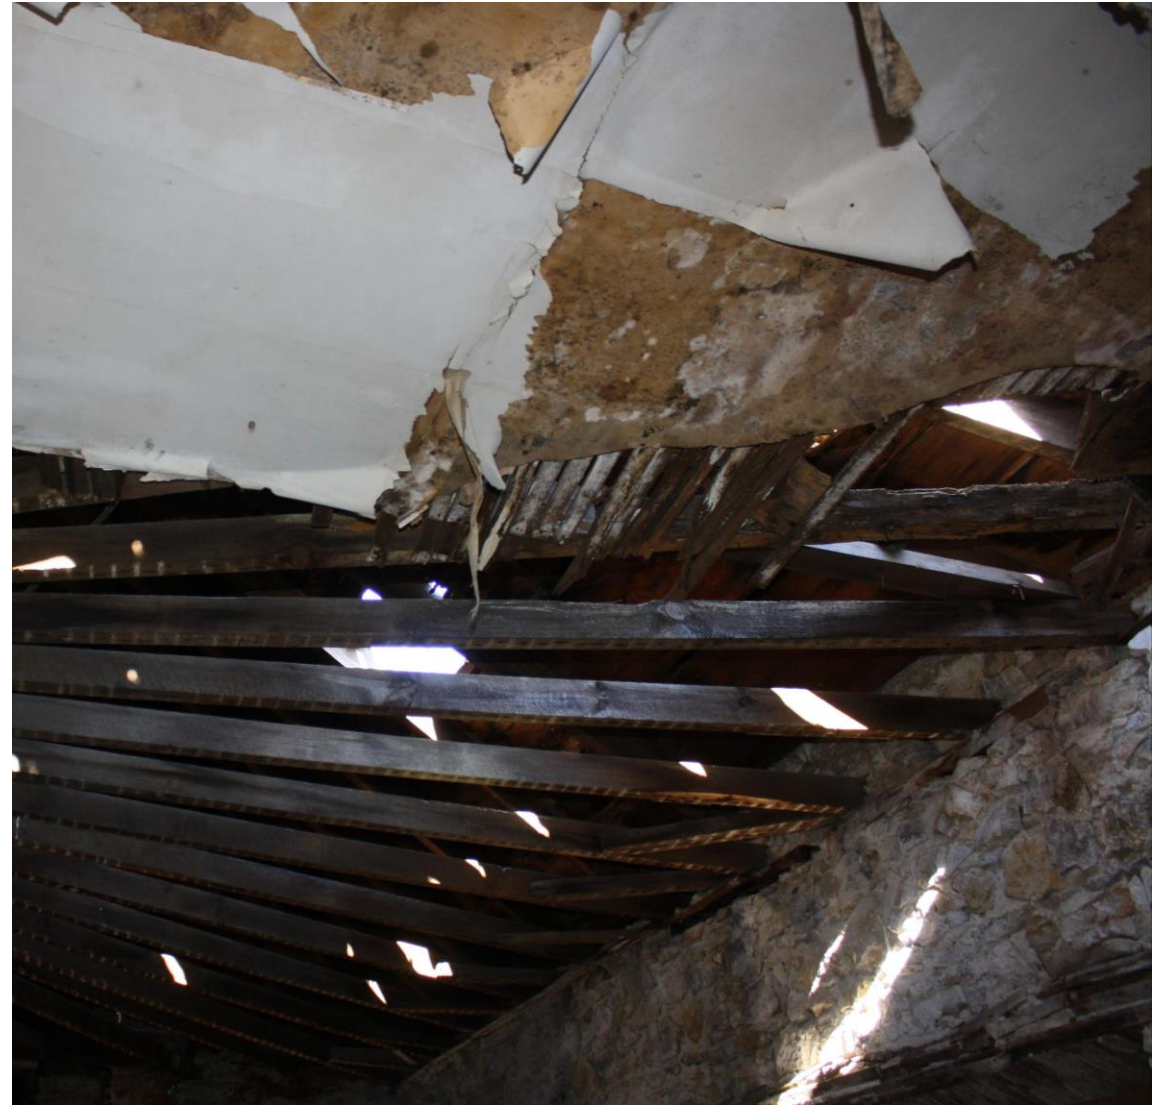
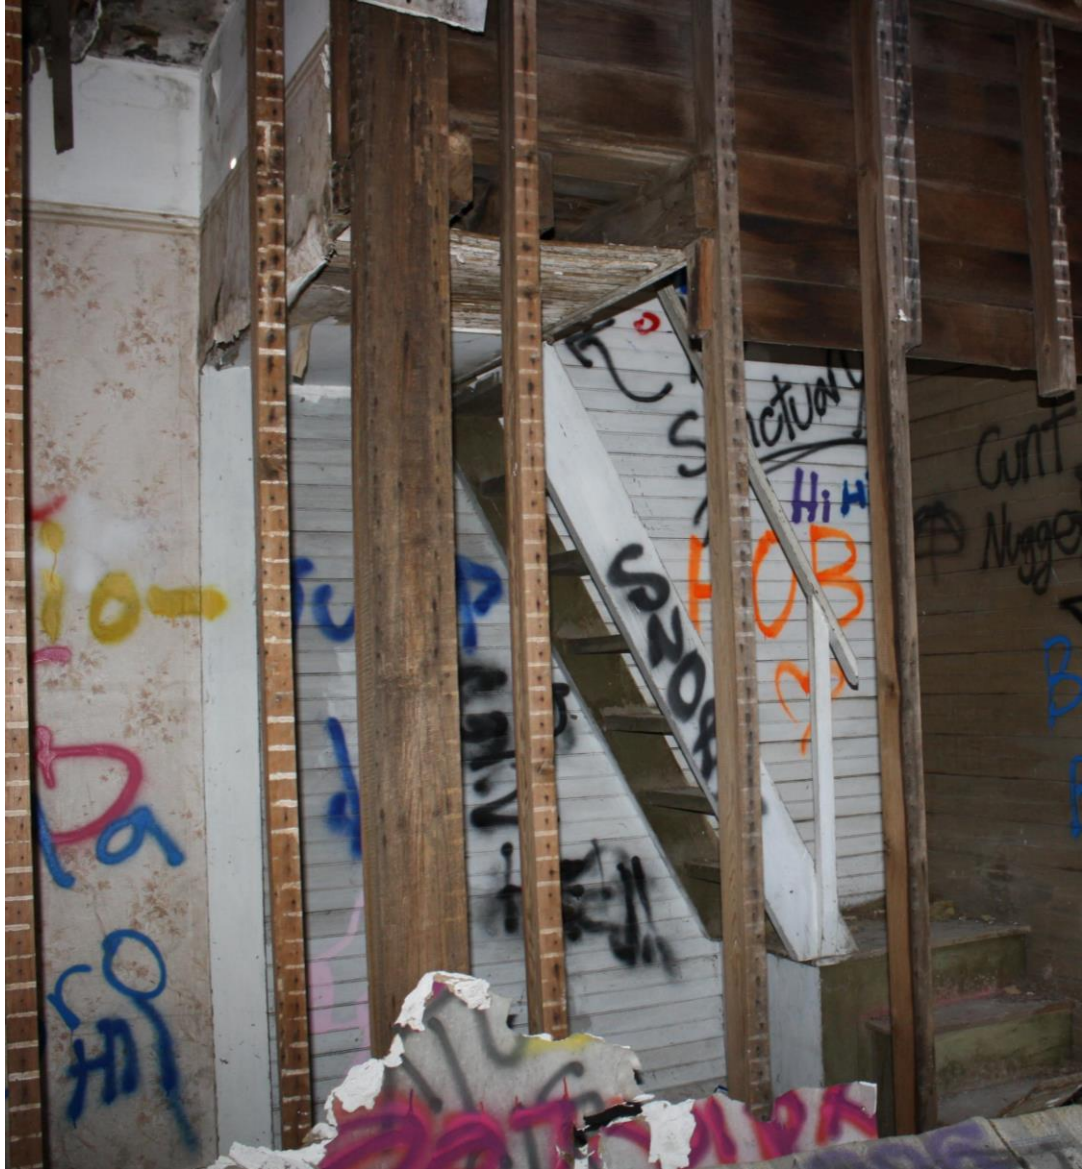
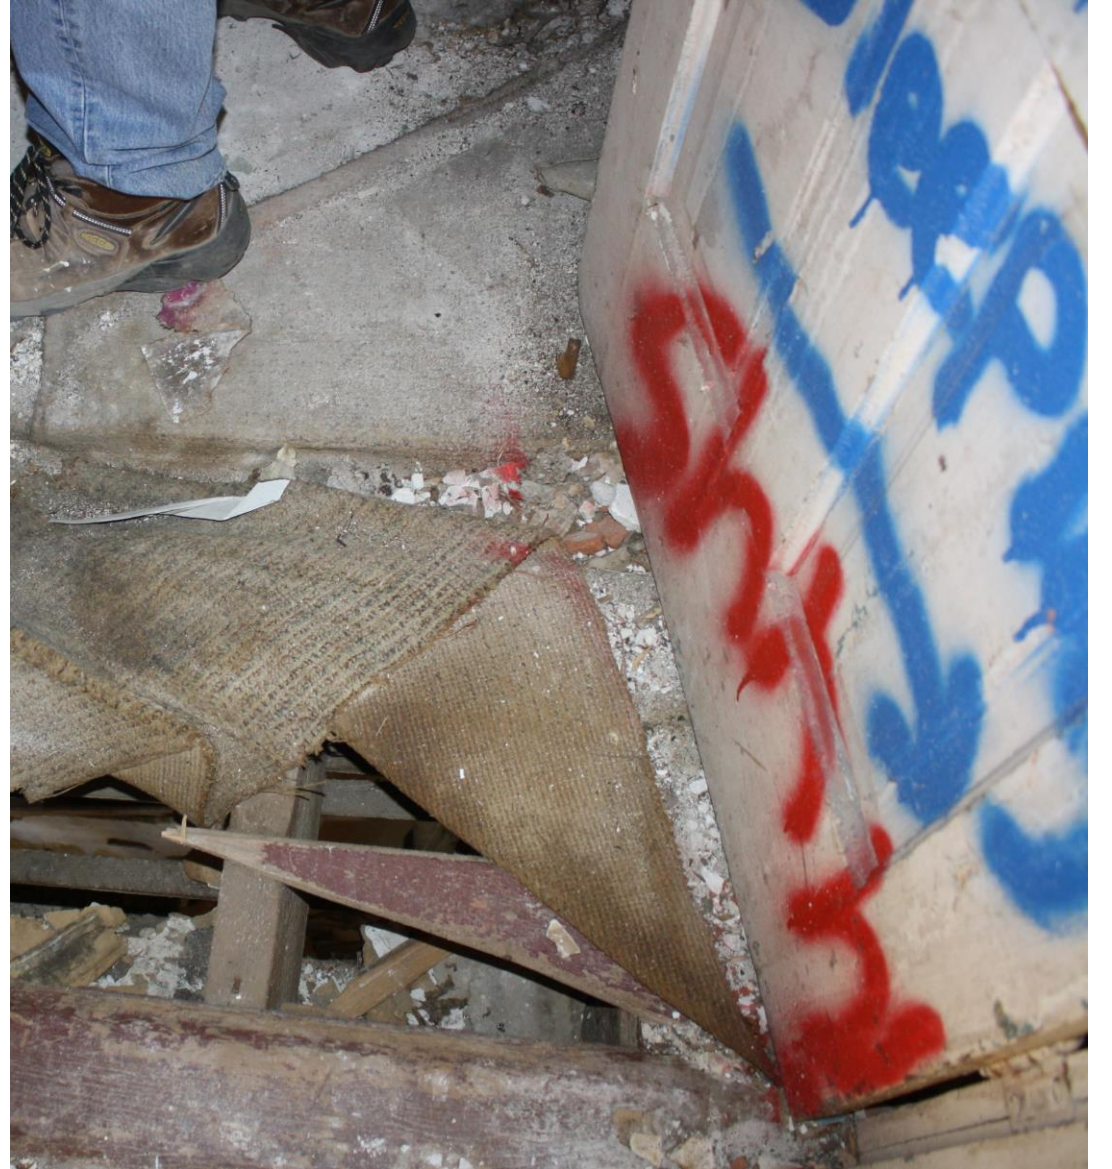
- Framed with full 2x8s.
- Ceiling joists are full 2x4s spaced a max of 24 inches on center.
- These are supported by exterior walls and wood-framed walls support the cupola floor and roof framing.
- Portion of floor rotted, located directly beneath hole in roof.

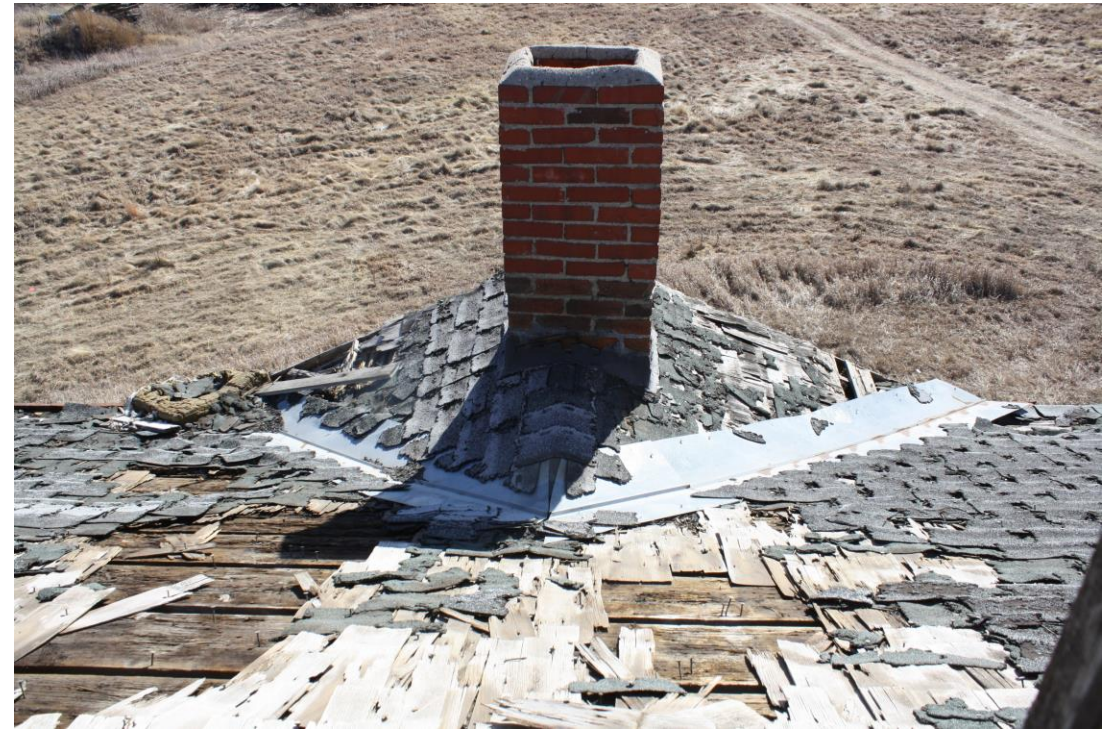
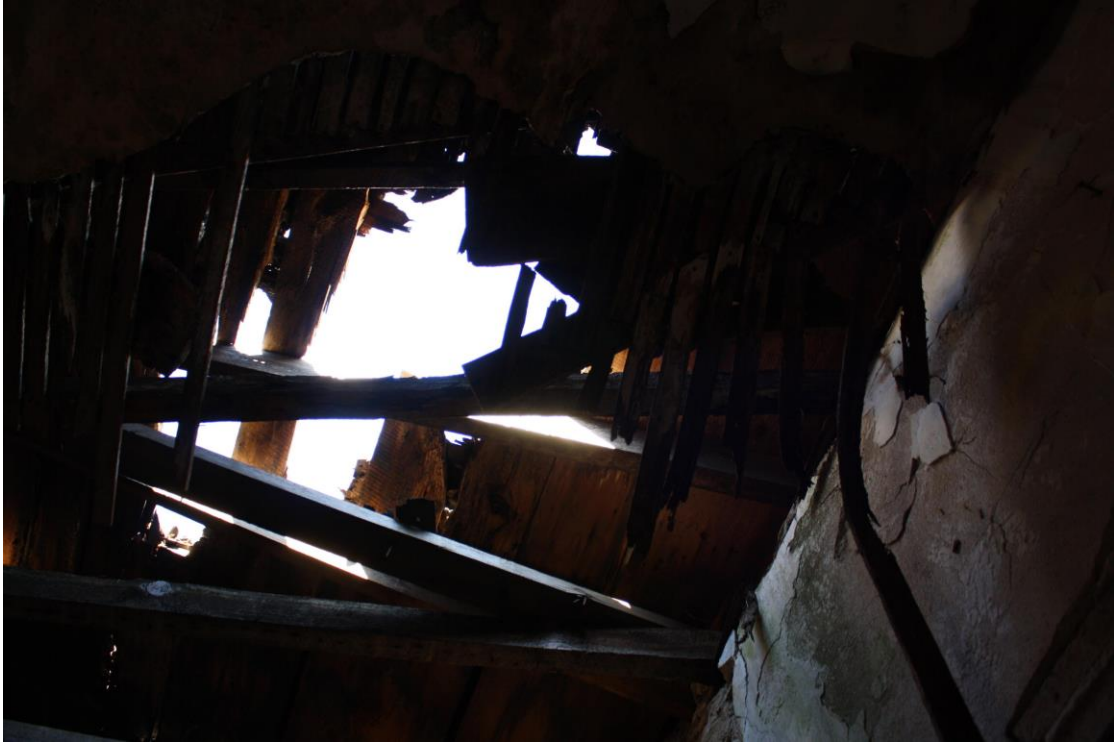
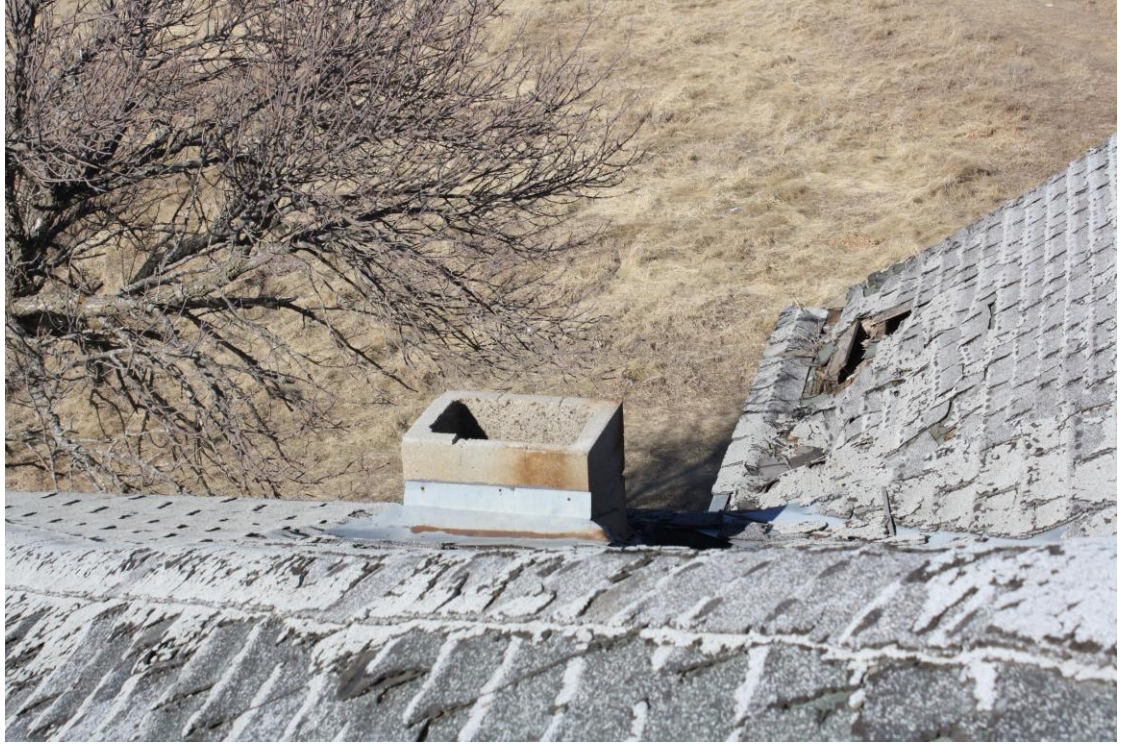
- Hipped main roof framed with full 2x6 rafters.
- Areas have failed and holes through the main roof at the east and south hips and the west face of the north gable.
- Some joists exhibit rot.
- Roof over northwest porch severely deteriorated

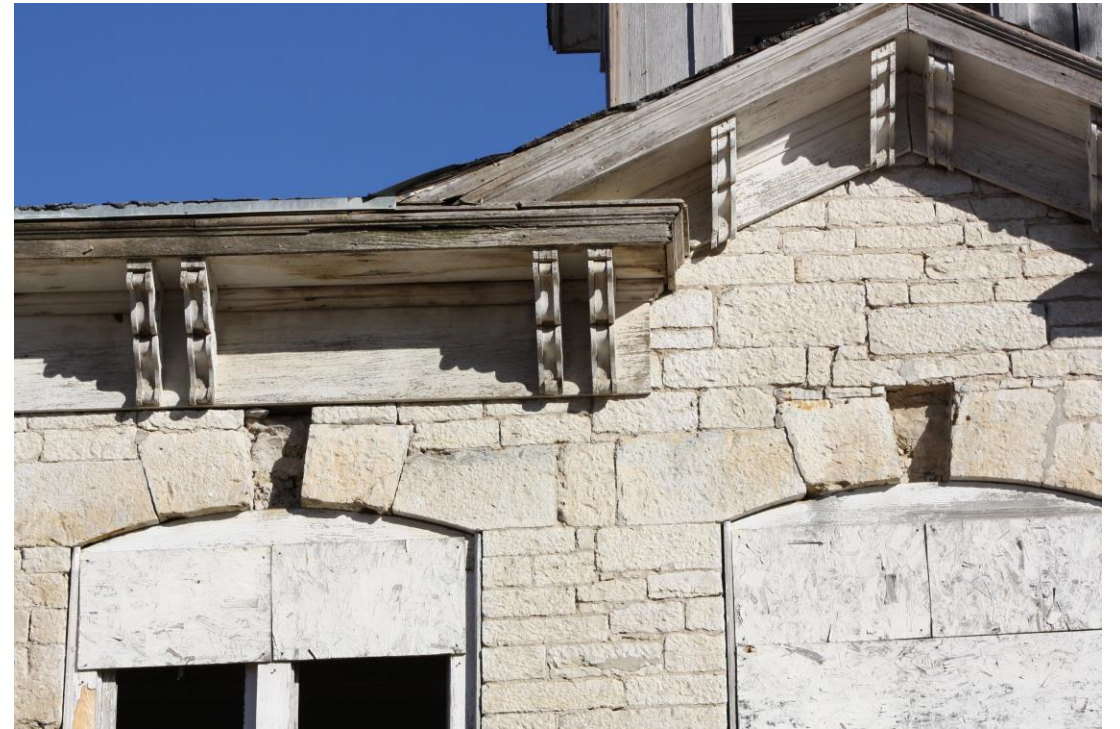
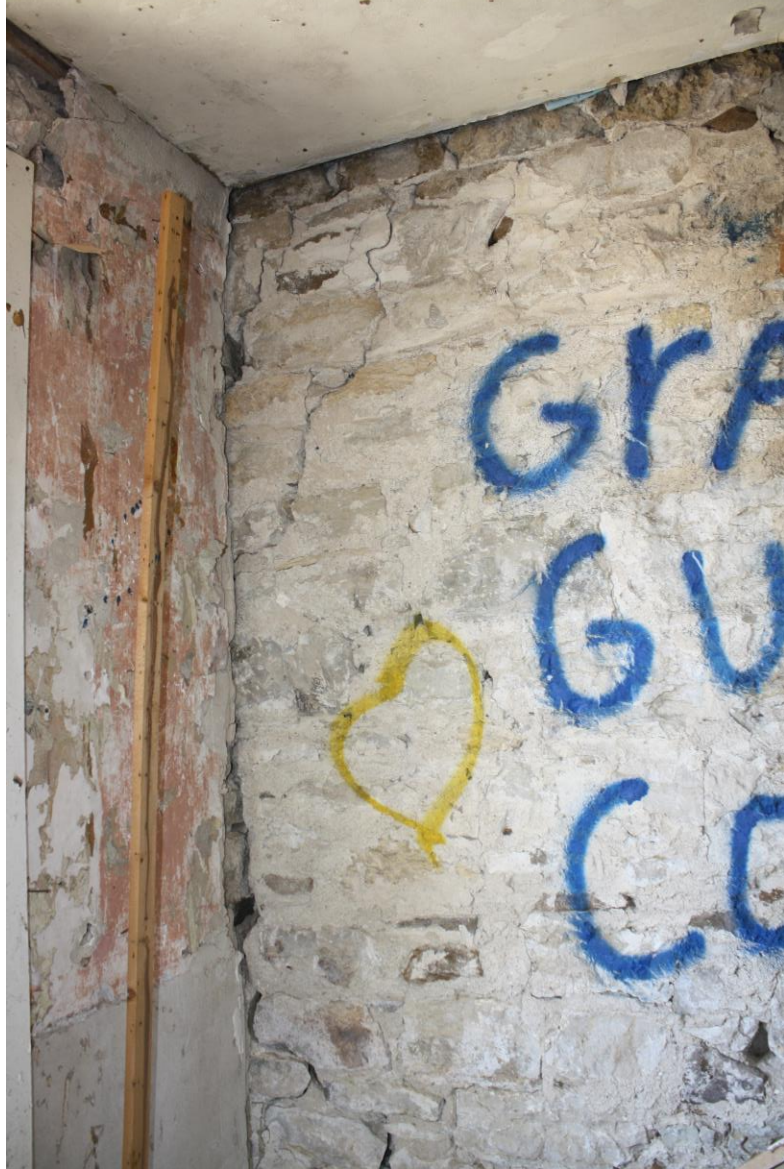
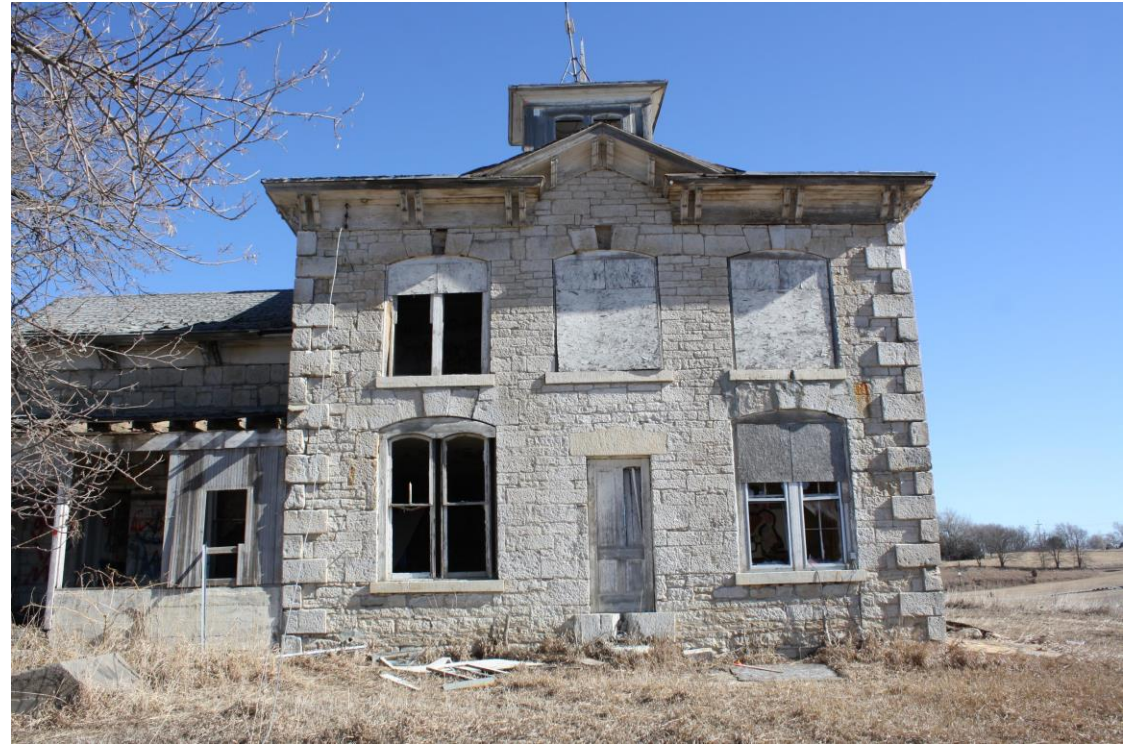
- Three chimneys, none are capped
- Cracks in masonry around chimneys
- Large crack in the NW corner of main house
- Arches over windows require repair (14)
- Weathered joints require repointing
- Cracked stone lintel over basement stair

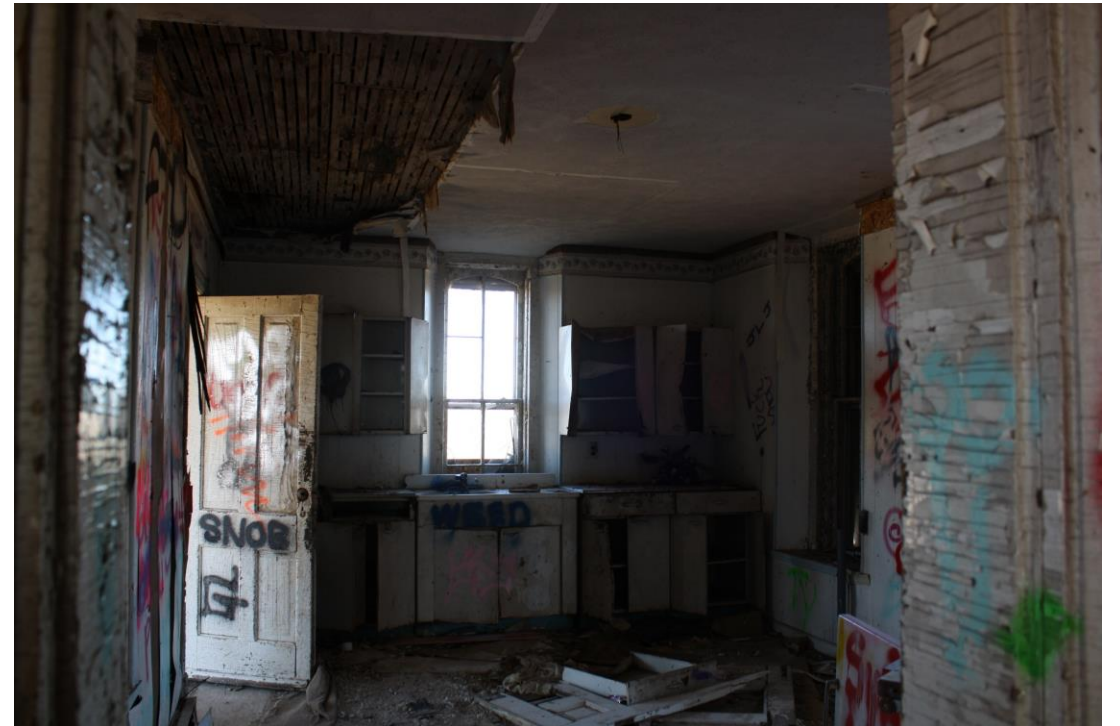
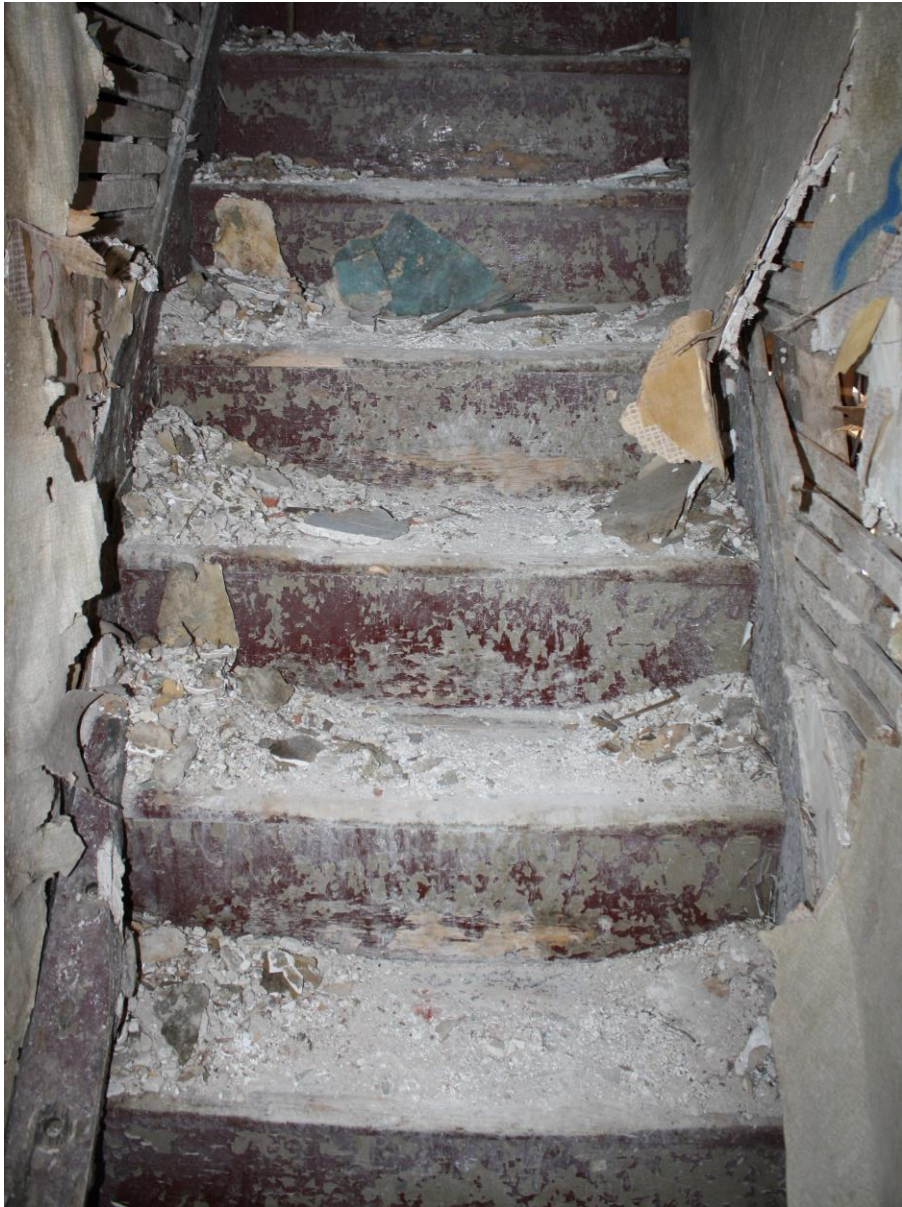
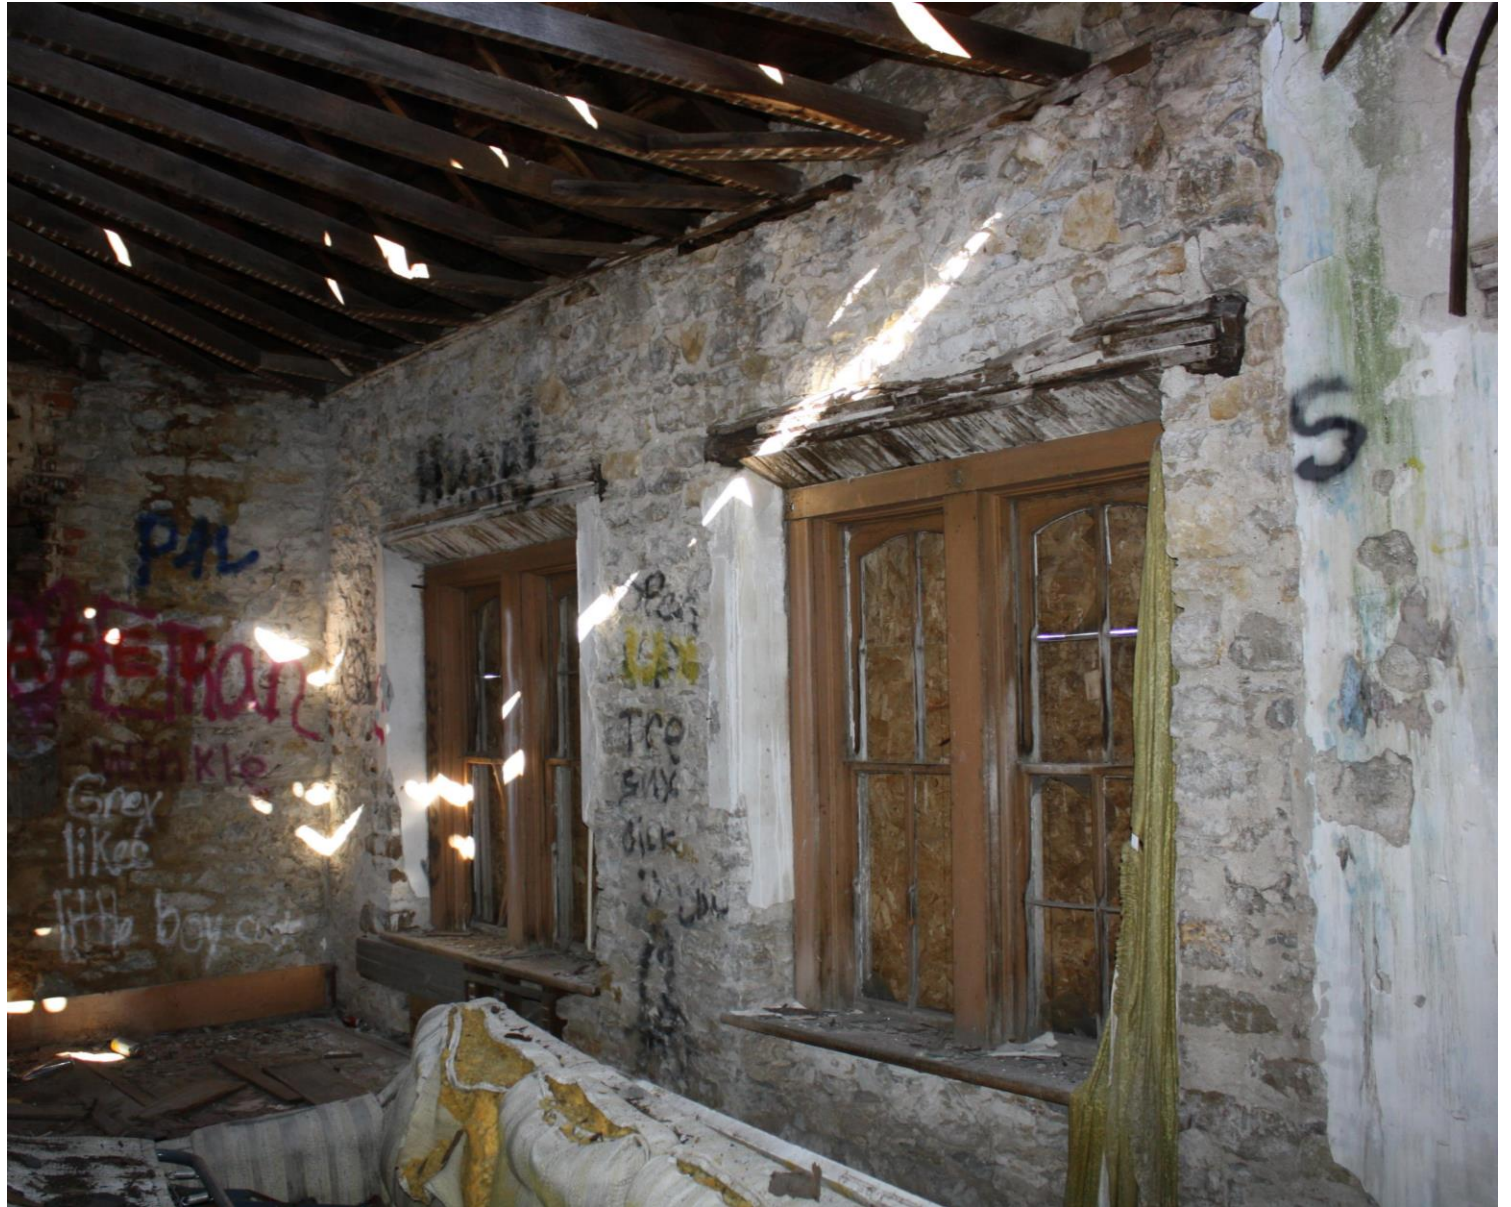
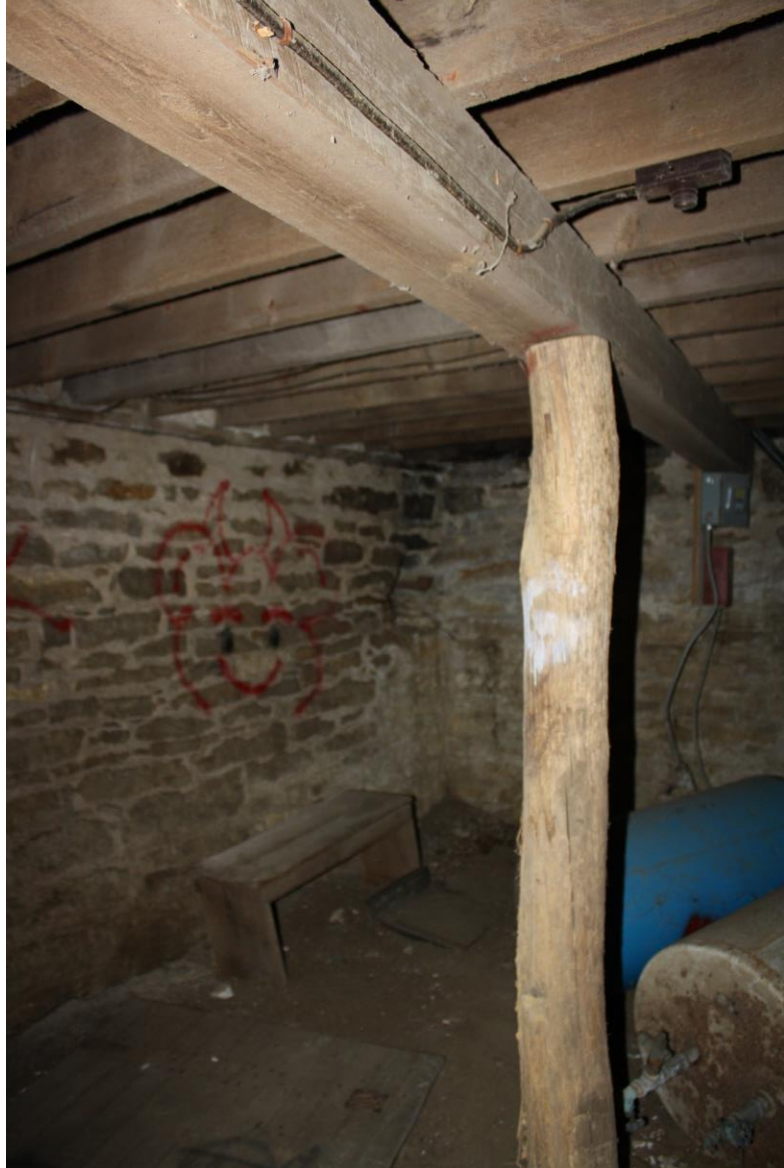
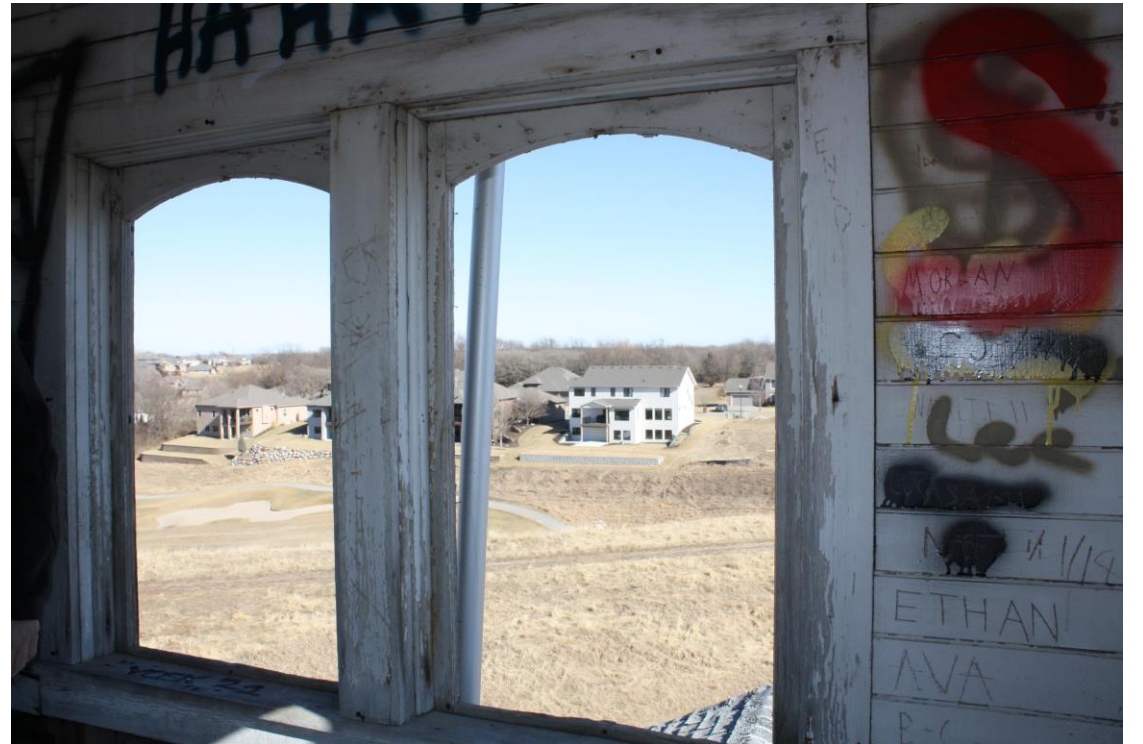
- Wood trim removed and historic finishes no longer present
- Interior physical integrity no longer exists
- Years of exposure and water infiltration has deteriorated interior features such as wood flooring and plaster
- Extensive vandalism
