# Israel Beetison House

Conditions and Structural Assessment

Prepared by Melissa Gengler  
and Mike Eisenbarth

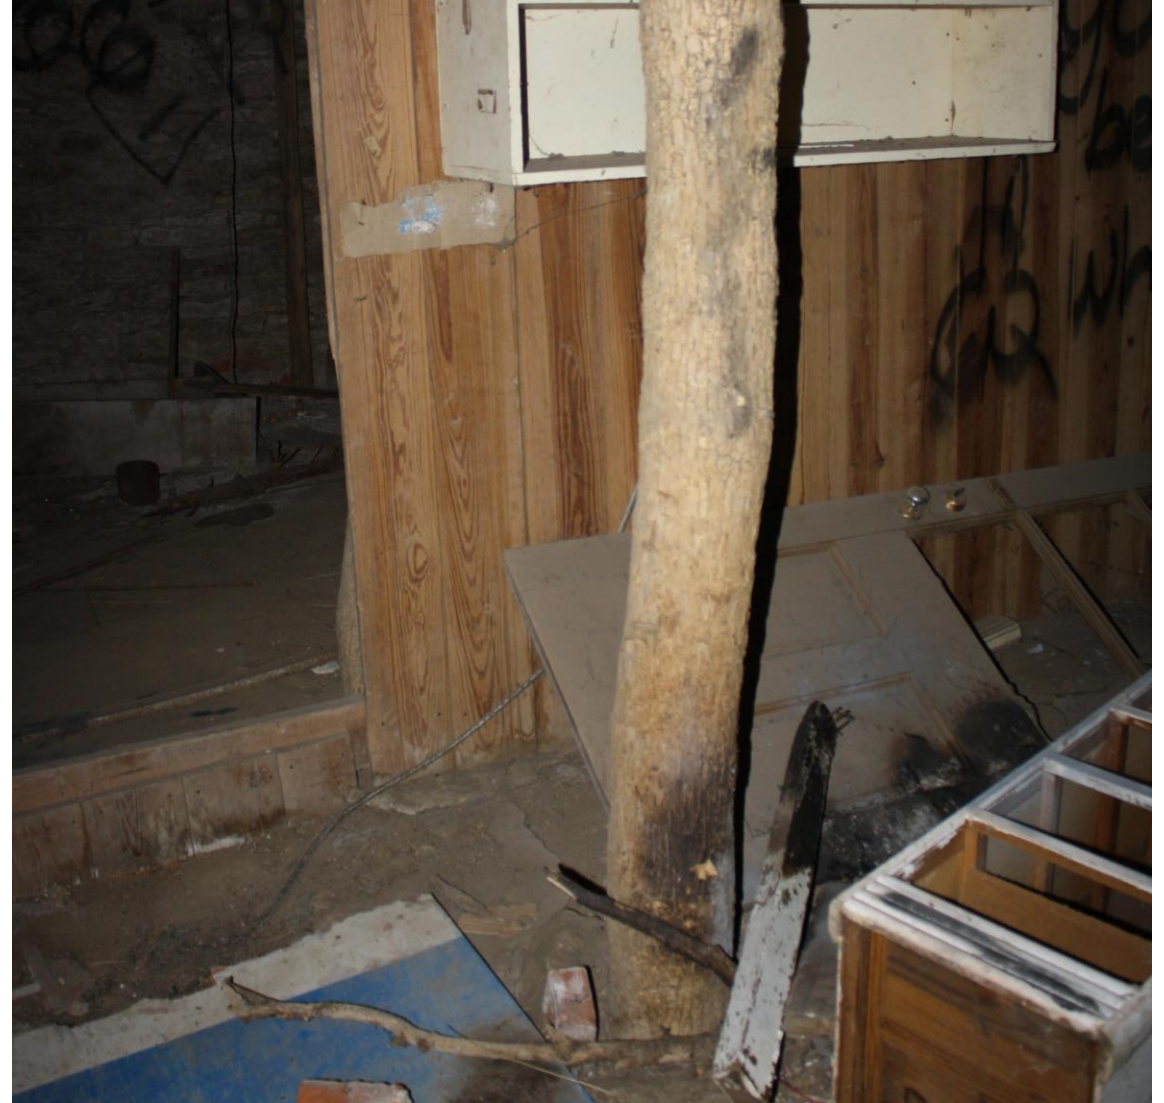
# Basement

- Two lines of wood posts and beams that run along a north/south axis down the center of the main house
- Unmilled timber consisting of round logs of varied diameter that support full 6X6 beams.

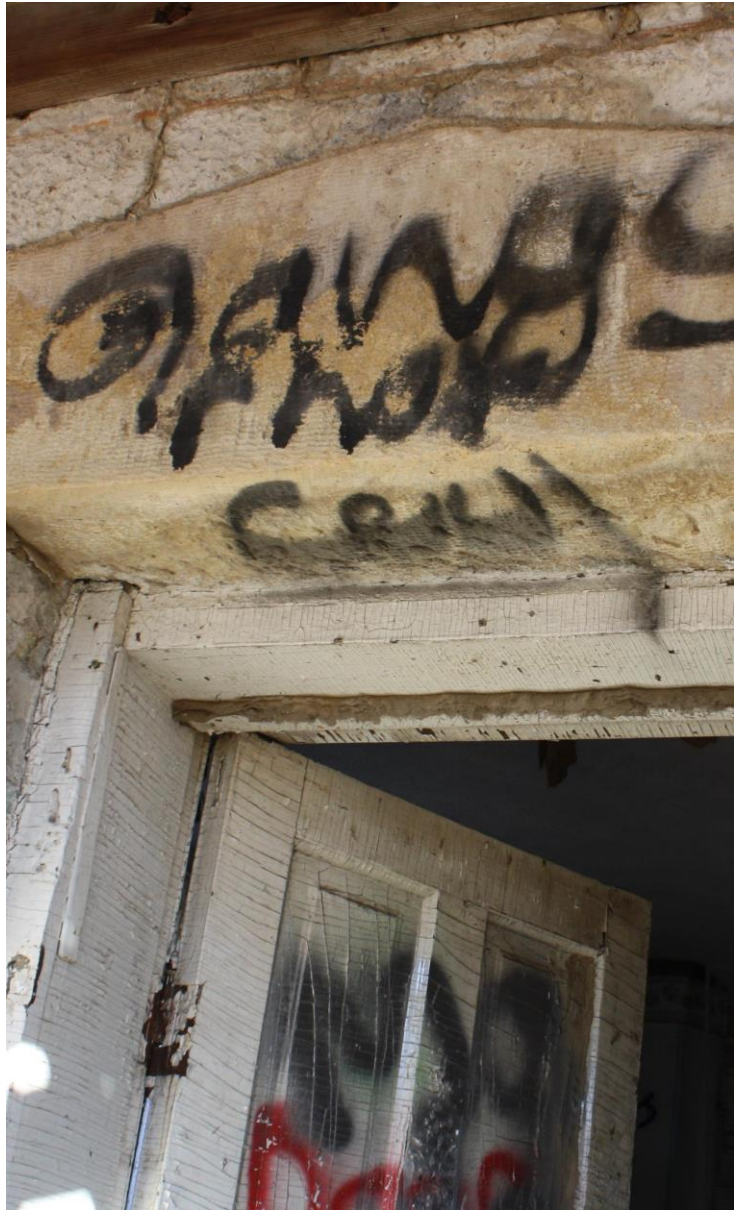
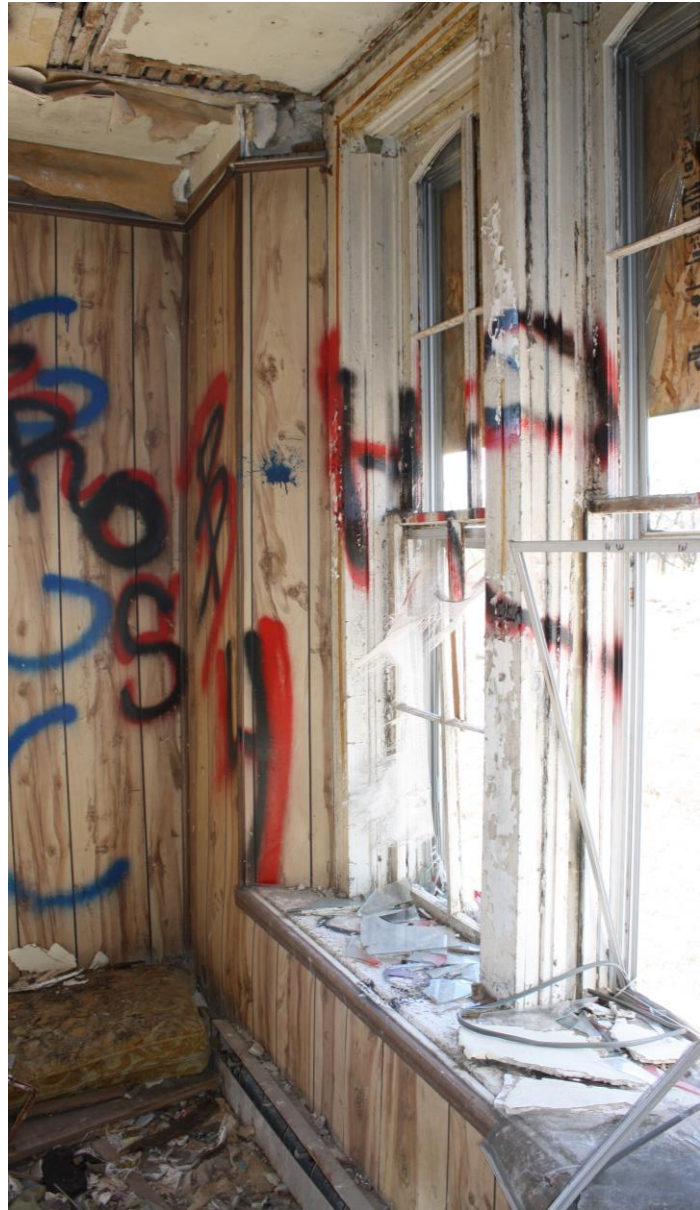
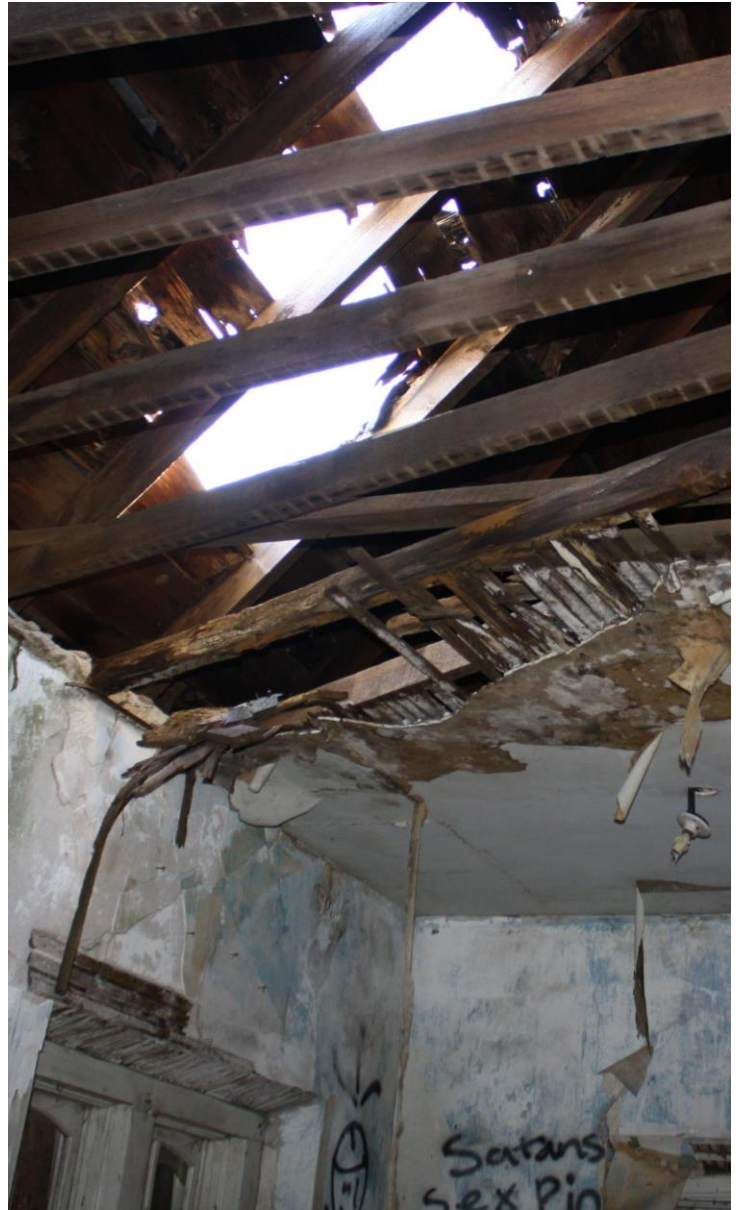
- Wood trim removed and historic finishes no longer present
- Interior physical integrity no longer exists
- Years of exposure and water infiltration has deteriorated interior features such as wood flooring and plaster
- Extensive vandalism

- No historic character defining features remain within building.
  - Structural stabilization and total renovation required.
- Replace roofing and deteriorated skip sheathing
  - Strengthen/replace damaged wood framing
  - Rebuild masonry arches and repair or replace stone lintel over basement stair
  - Repoint
  - Shore and rebuild joist bearing
  - Enclose building envelope
  - Install steel caps over chimneys
